POWROLL TECH

ADDITIONAL INFORMATION - TRX400EX AND XR400R HEAD GASKET FAILURE

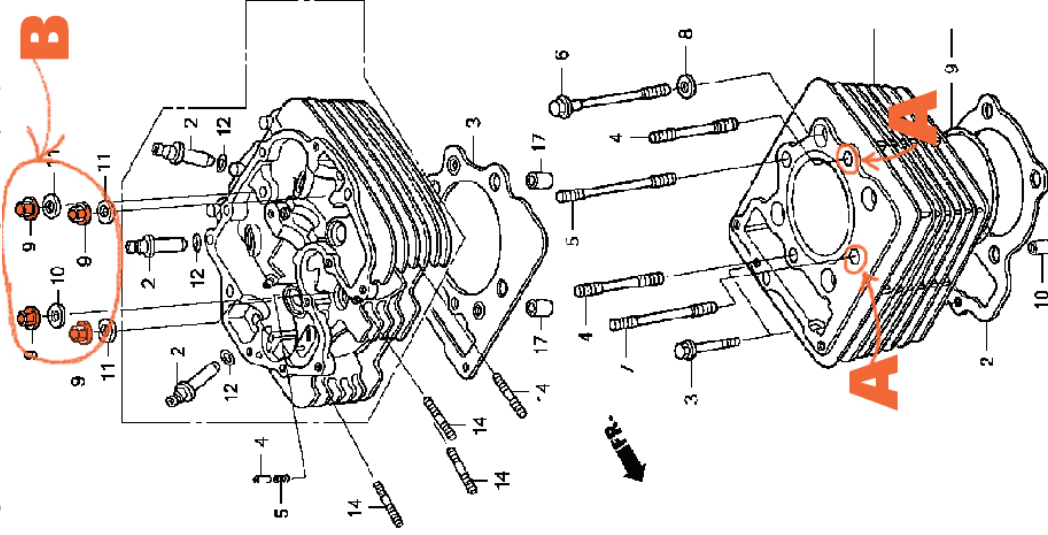
Due to the cylinder and stud design on this model, some engines may experience more frequent headgasket failures.

The front studs (A) are located closely to the cylinder sleeve, which leaves very little gasket surface for this area.

Immaculate preparation and proper torque procedures must be followed any time a new head gasket is installed. Powroll recommends using new Honda studs. If excessive gasket leakage has occurred previously, the cylinder may need to be replaced, as oversized studs, Helicoil or other inserts may not seat in the old aluminum due to annealing.

To avoid these issues, start with cylinder in good condition (no pre-existing leaks), new studs, clean installation techniques, then follow Honda's torque specifications. **Most importantly, re-torque (B) after a few heat cycles!**

Honda Torque Specs:

- Cylinder head cover bolt -- 8 lbf-ft
- Cylinder head nut -- 33 lbf-ft
- Cylinder bolt -- 33 lbf-ft
- Cylinder stud bolt -- 33 lbf-ft
